EUROPEAN CATHEDRALS

THE RESTORATION OF 86 FIGURES OF SAINTS IN THE CHOIR VAULT OF BERN CATHEDRAL: A MULTI-LAYERED CHALLENGE

Dip Arch Annette Loeffel

Berner Münster-Stiftung, Switzerland

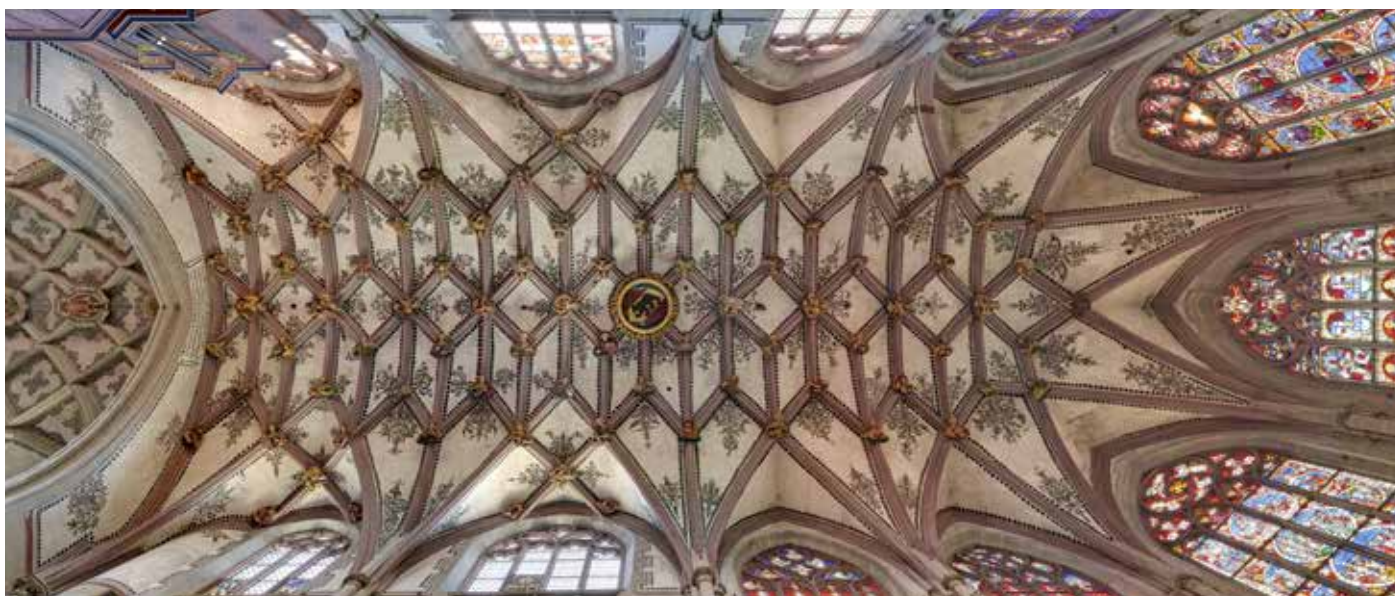
Fig.1: General view of the choir vault after conservation. 2017, Nick Brändli.

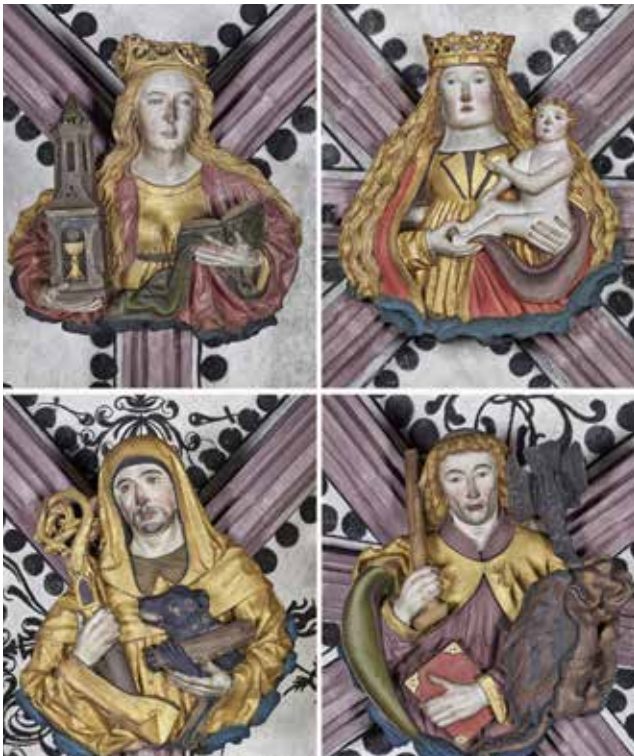
Fig.2: Final status photos of the figure busts after the conservation. Top left: Barbara, top right: Maria, bottom left: Gallus, bottom right: Beatus (local saint). 2017, Nick Brändli.

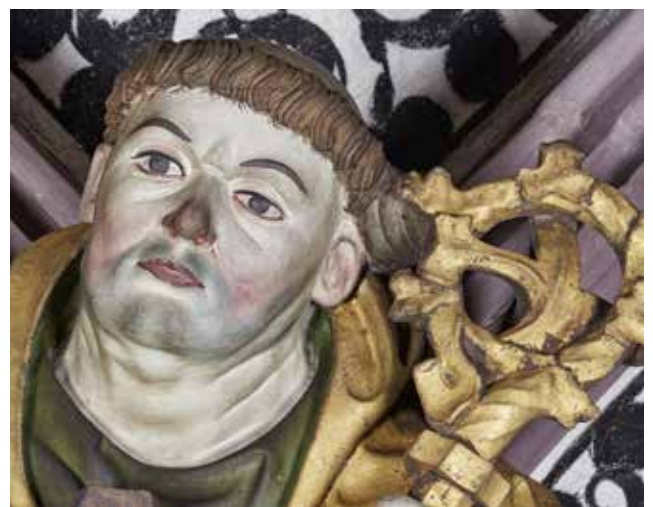
Fig.3: Detail of Otmar, after cleaning. 2017, Nick Brändli.

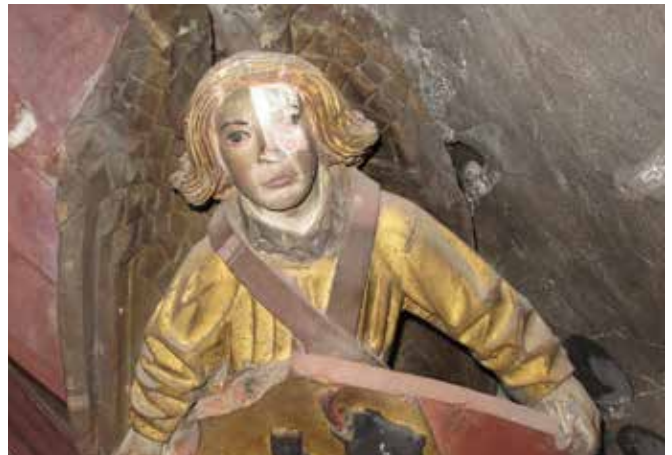
Fig.4: Sondage from 1990. A restorer was commissioned to search for the medieval colour version, unaware that he had the original in front of him. In the process, the artwork was severely damaged. 2014, Berner Münster-Stiftung.

Further damage was caused by sondages in the 1990s, when the desire to restore the vault arose for the first time. A restorer was commissioned to search for the original colour version. In the process, several stones were severely damaged. With the preconceived notion that the old vault would certainly be overpainted several times and in ignorance of the church's historical circumstances, he made soundings on several figures down to the stone base. Unaware that the original was right in front of him, he mistakenly concluded that no traces of the original existed under the visible version, leading him to believe that the original was lost. This misconception persisted until 2012.

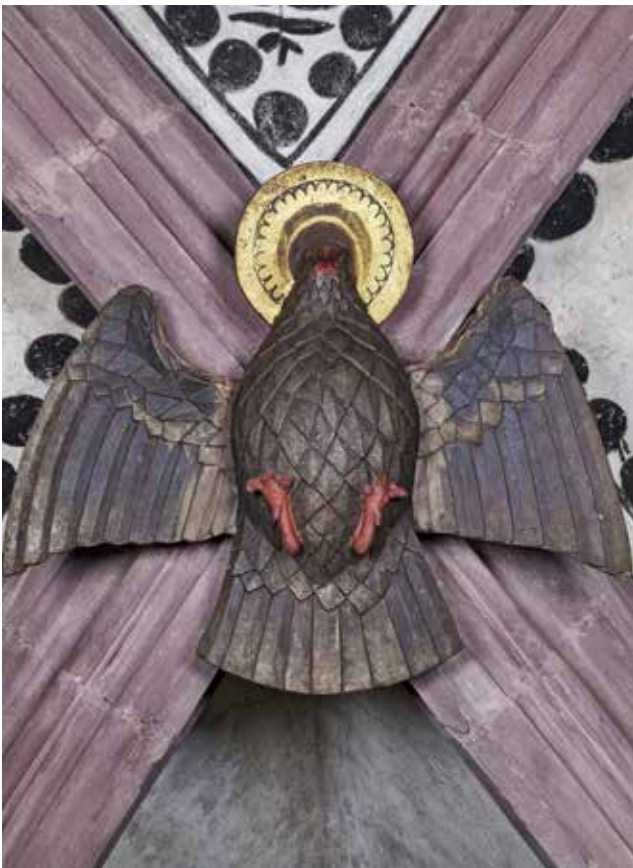
Fig.5: The central easternmost keystone: the Dove representing the holy spirit. Picture taken after cleaning and conservation. 2017, Nick Brändli.

Over the centuries, however, the silver plating had been altered by oxidation and the originally brightly shimmering dove had become unrecognizable. Suddenly, questions about the best possible techniques for preserving the historical value were eclipsed by discussions about the iconographic significance of the bust and its current religious value in everyday church life: Should and may the symbolism of the work of art be placed above its authenticity here?

A comprehensive examination of the colour composition of the keystone in question led to clarity: Further fine paintings lay over the silver plating.¹⁰ The exact colour structure cannot yet be fully understood, as this is where today's analysis methods reach their limits. In order to allow future generations to find out more about the work of art with the possibility of new examination methods, a decision was made together with the parish to preserve the aged, authentic condition. The scope for interpretation remains too high and a modern re-silvering could never even come close

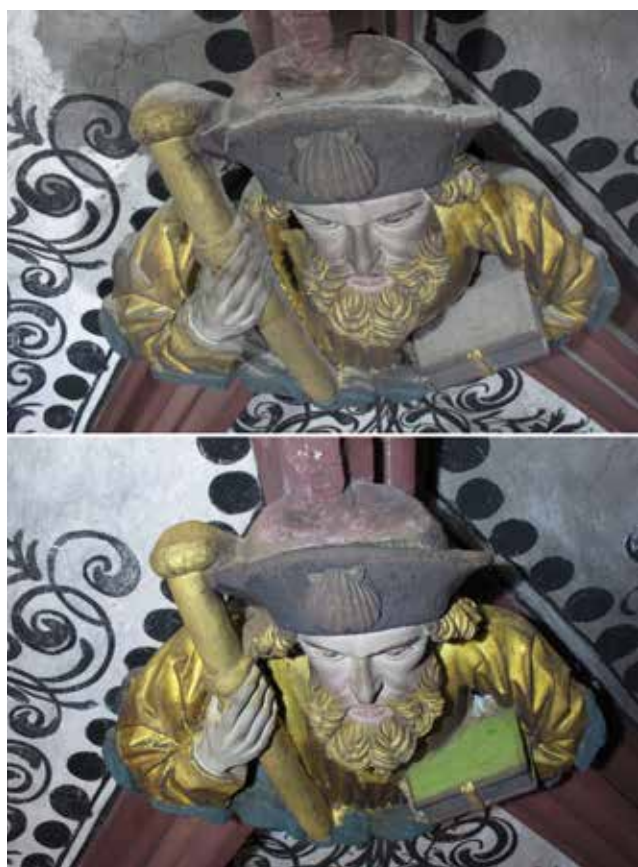
Fig.6: Jakobus the elder, pre-state 2014 (top) and final state 2015 after the cleaning (bottom). Berner Münster-Stiftung.

The busts of the figures were carefully cleaned. Moreover, neither retouching nor new gilding or silvering was carried out. The largest part of the work here consisted of a comprehensive survey and documentation of the findings. Binders and pigments were examined in detail.⁹

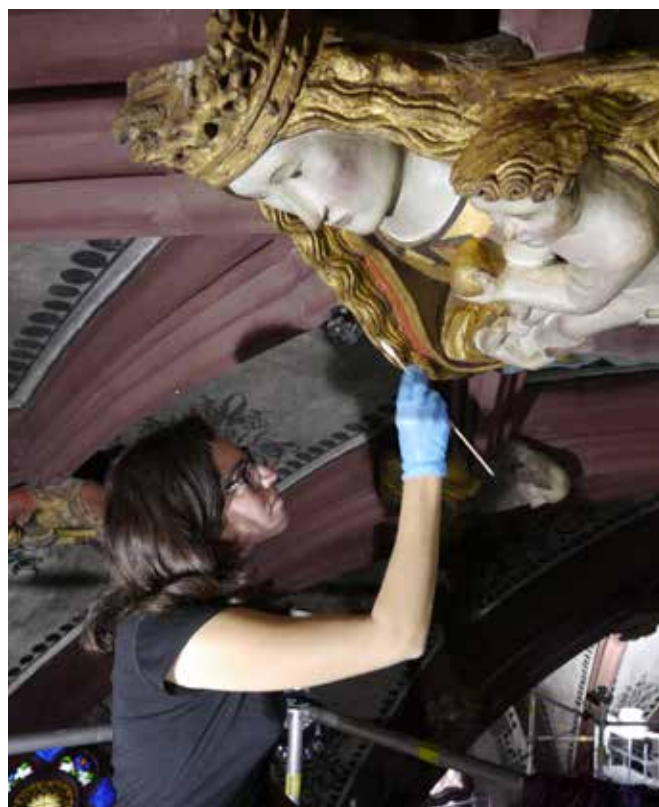
Fig.7: Work in progress: cleaning of one of the keystones (Maria). 2015, Berner Münster-Stiftung.

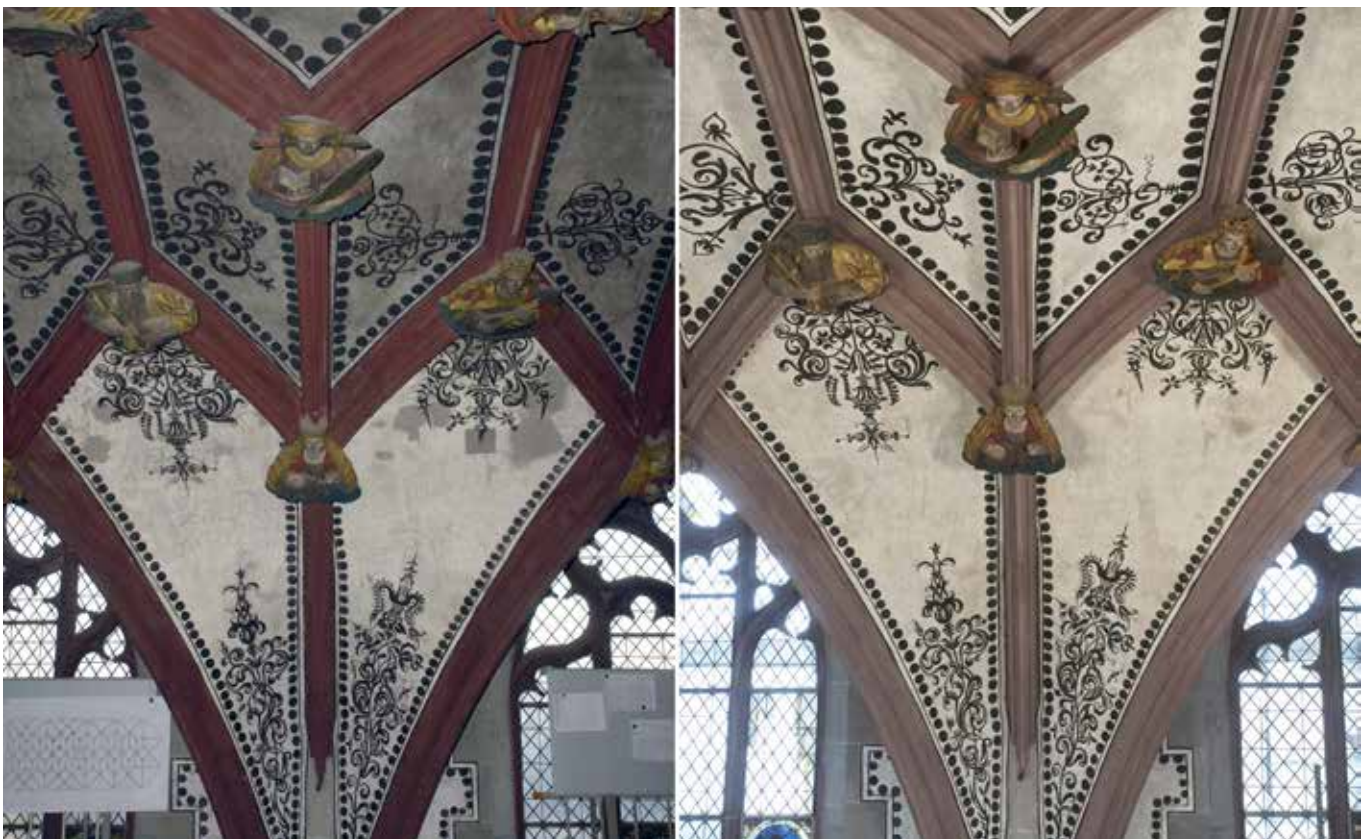
Fig.8: Intermediate state of an exemplary axis in the choir vault: partially cleaned with visible grey retouching from 1910 (left) / final state after cleaning and painting over the vault ribs (right). 2015 / 2017, Berner Münster-Stiftung.

The only exception to the purely conservational concept was the handling of the colour of the vault ribs. These had been painted over in 1911 in a dark red, which had matched the dirty condition at the time. At the end of the restoration, it was decided to return them to the original light shade of red. The original shade could be found on the backs of the figures. Uncovering the original proved to be feasible neither from an economic nor from a conservation point of view. The ribs were finally painted over with a glaze of silicate chalks and water using a completely reversible technique.

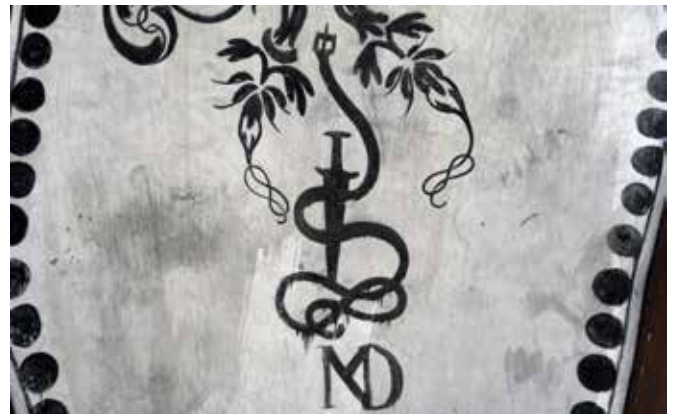
Fig.9: Signature of the artist Niklaus Manuel Deutsch from 1517 in a vault panel on the north-east side of the choir vault (picture taken after cleaning). It is clearly visible how the thin paint ran down at the time of construction and how the vault caps were stained from the beginning. 2017, Berner Münster-Stiftung.
